# EVALUATION REPORT

This case history shows comparison between performances of drilling with repaired and new bits. The objectives is to show that repaired bits performance is as good as of new ones.

For drilling Apache well in Kalabsha oilfield was decided to use repaired PDC bits.  
Well design:

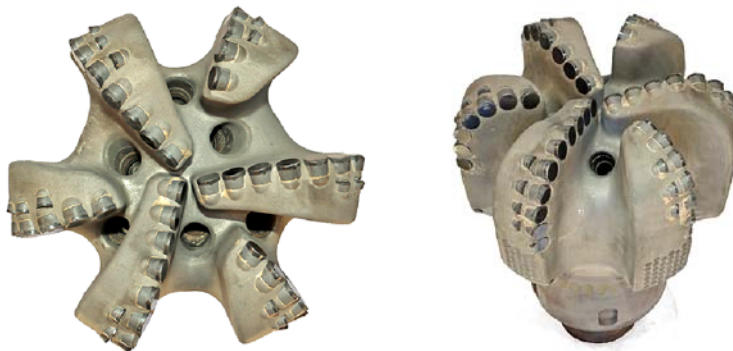
DP606X, s/n 7903727

DULL GRADE							
Cutting Structure				Bearing	Gauge	Remarks	
I	O	D	L	B	G	O	R
1	2	BT	S	X	I	WT	TD

The bit came out of hole in good condition. Main cutters on nose area without wear. The normal wear of cutter on shoulder of each blade. The bit is in repairable condition.
